Aerial Photograph Anomaly 44

Aerial Photograph Anomaly Program
Marine Corps Air Station, El Toro, California

3 November 2000

Prepared by
Southwest Division, Naval Facilities Engineering Command
BRAC Program Office
1230 Columbia Street, Suite 870
San Diego, CA

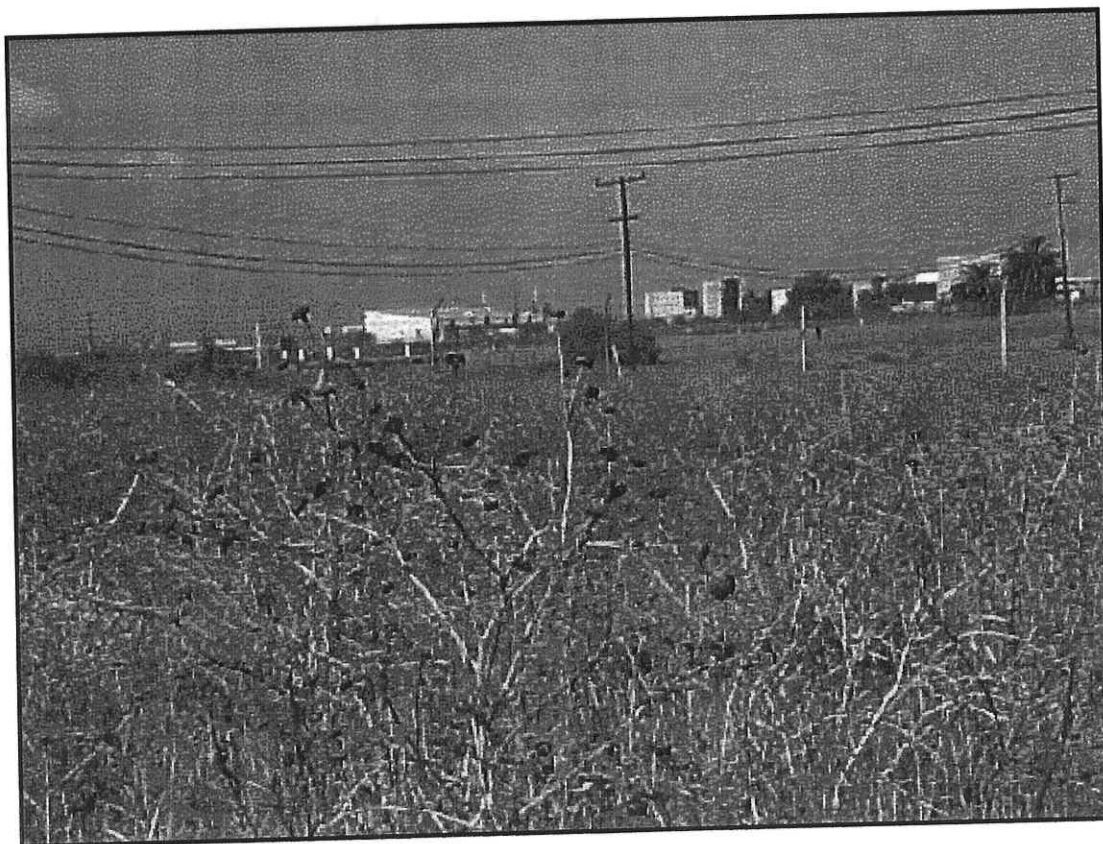
Photograph 2. APHO 44 (SAIC 288 (1974 Photograph)) Vicinity.
Disturbed Ground, Mounded Material, and Probable Trench
Aerial Photograph Anomaly Program
Marine Corps Air Station, El Toro

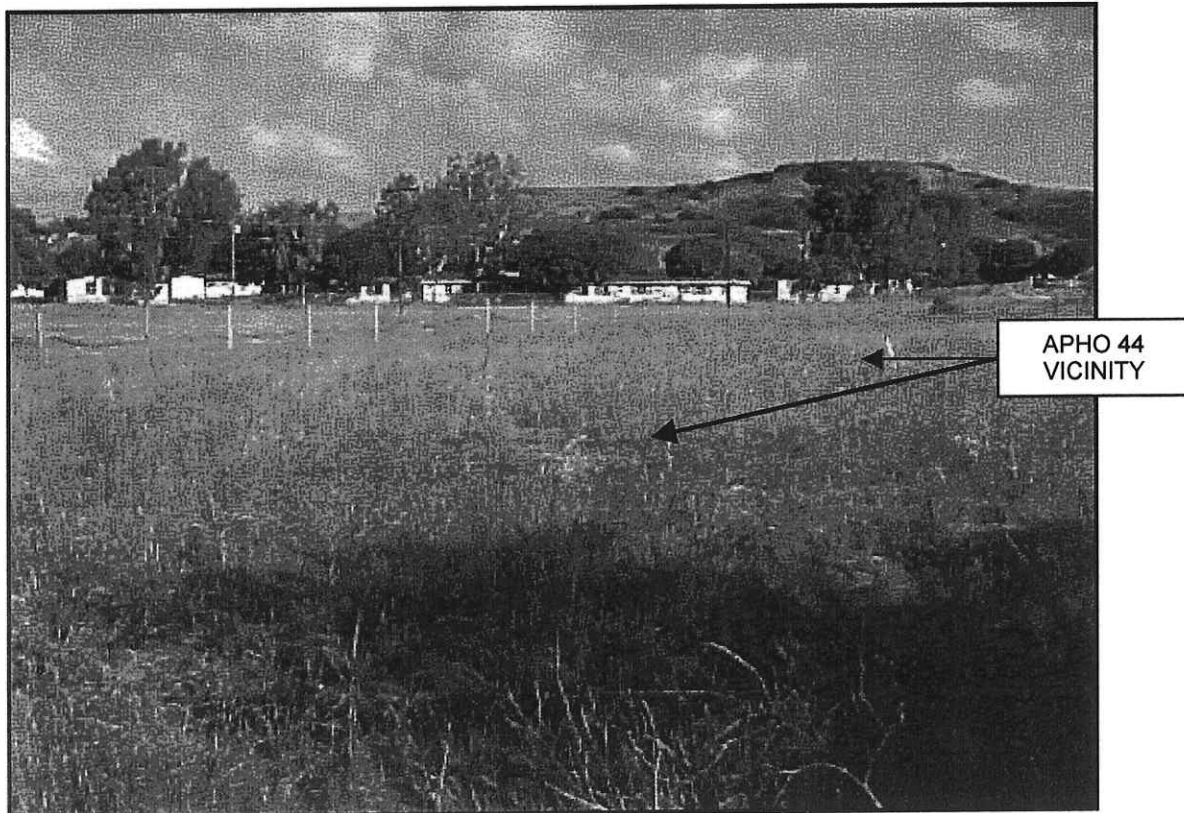
Photograph 3. APHO 44 (SAIC 288 (1974 Photograph)) Vicinity.
Disturbed Ground, Mounded Material, and Probable Trench
Aerial Photograph Anomaly Program
Marine Corps Air Station, El Toro

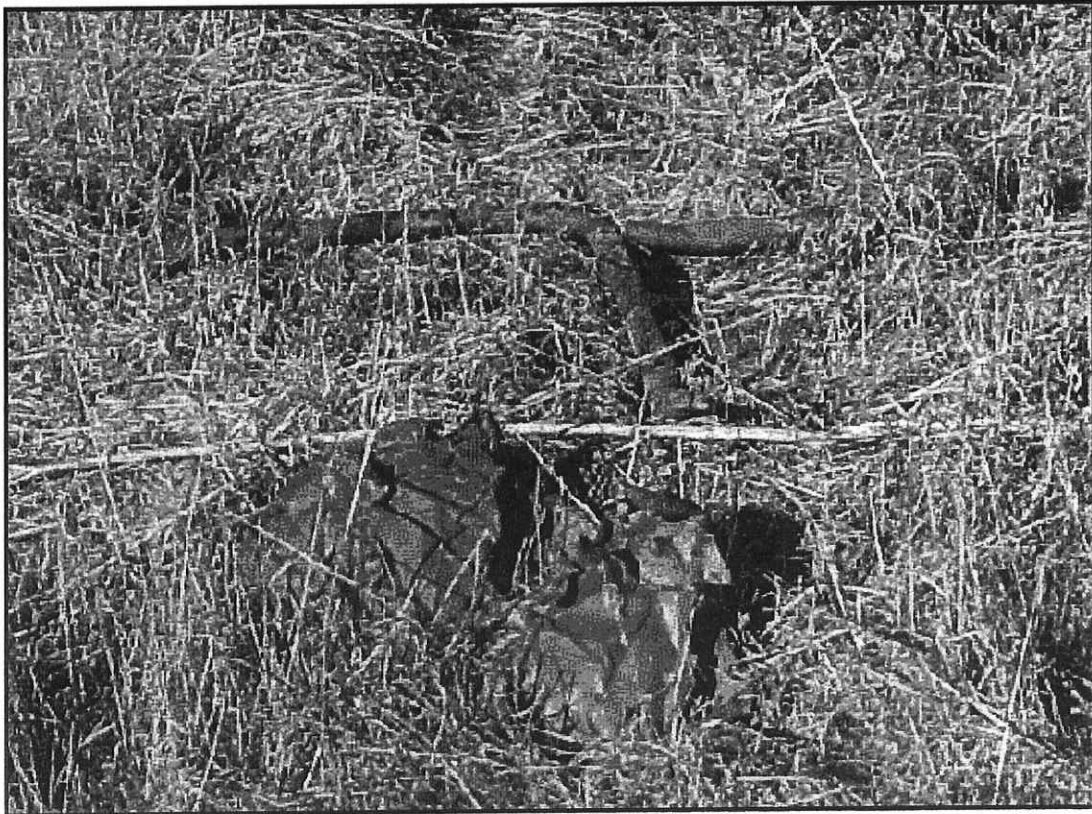
Small areas of construction debris, including concrete rubble and metallic debris, were observed on the ground surface during the visual inspections of the site. Construction debris is also present at the southern end of IRP Site 17. It is possible that construction debris was accidentally placed on the ground surface near or at APHO 44 during the transport of debris to the southern section of IRP Site 17.

Photograph 4. Installation Restoration Program (IRP) Site 17 -
Communication Station Landfill, Southern Area (Construction Debris)
(East of APHO 44 (SAIC 288))
Aerial Photograph Anomaly Program
Marine Corps Air Station, El Toro

- APHO 44 is located near the southwestern section of IRP Site 17, and consolidation of approximately 14,500 cubic yards of debris is planned as part of the final remedy for IRP Site 17. It is recommended that construction debris within the APHO 44 study area be consolidated in a similar manner to the debris identified for consolidation at IRP Site 17 during the implementation of the final remedy.

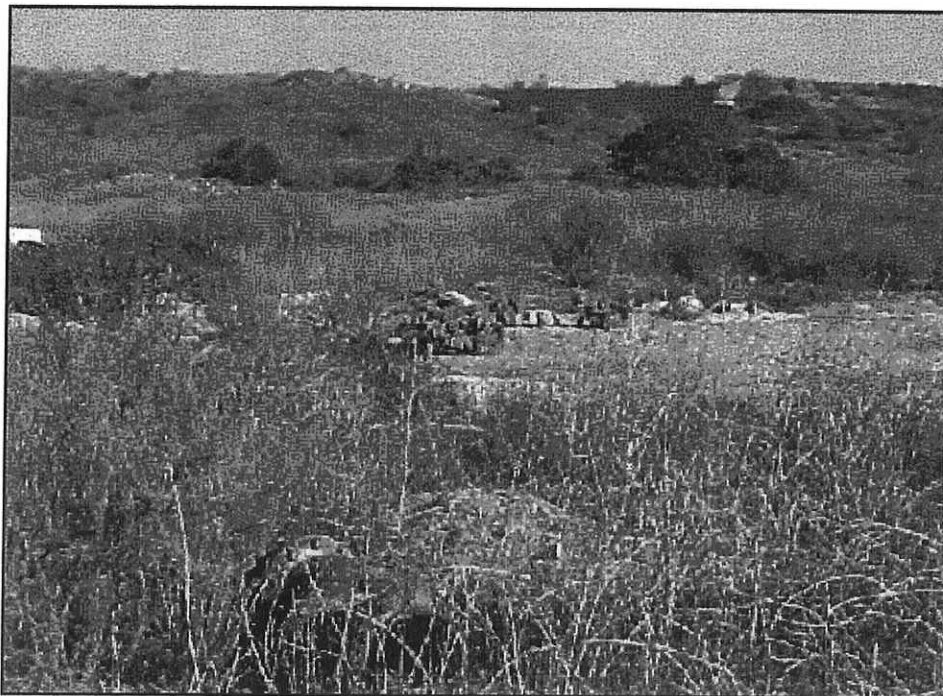
Photograph 5. APHO 44 (SAIC 288 (1974 Photograph)) Vicinity.
Disturbed Ground, Mounded Material, and Probable Trench
Aerial Photograph Anomaly Program
Marine Corps Air Station, El Toro
